**Housebusters Inc.**  
"Who You Gonna Trust...?"

**This Inspection Report has been**

**Location of the Property**  
8888 Anywhere Street  
World, US 00000

**Summary Report**

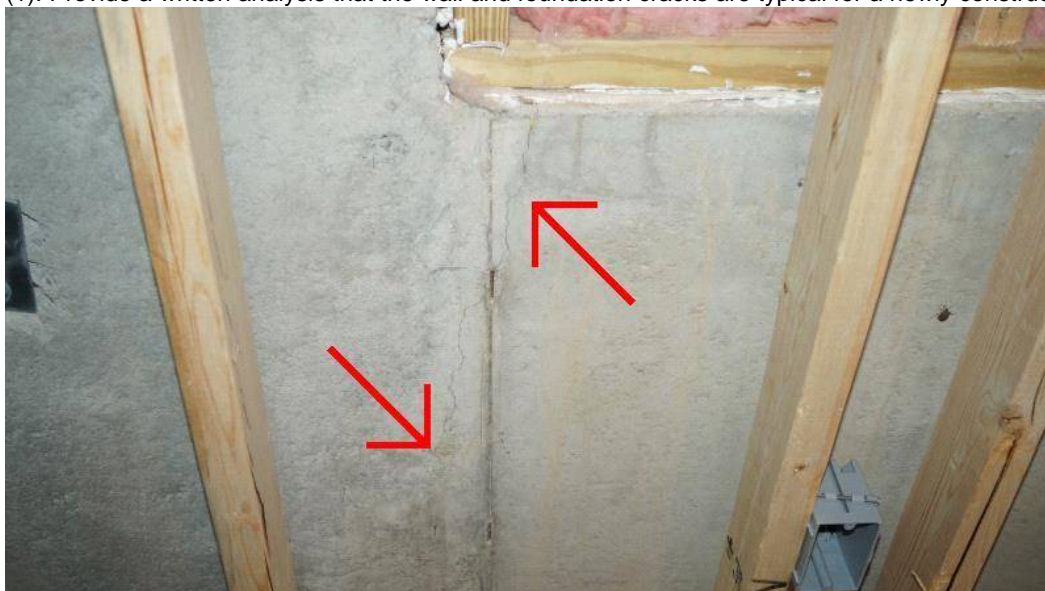
**Exterior Foundation Walls: Visible Portions**

The exposed portions of the perimeter foundation wall at the left side near the AC unit has a vertical crack. This crack is minor in nature, however the crack extends through the poured concrete foundation wall. The poured concrete floor on the interior adjacent to the foundation wall has multiple cracks beginning at the Garage foundation wall. Though this could be considered typical settlement in the first 5 years. this house is less than 1 year since construction commenced.

There are no WV State Code Officials in this area, ask the builder for the 3rd party building inspections performed during construction. If there are no 3rd party inspection reports during construction, contact a WV Licensed PE that is licensed & insured as a Structural Engineer.

(1). Provide a written analysis that the wall and foundation cracks are typical for a newly constructed house.

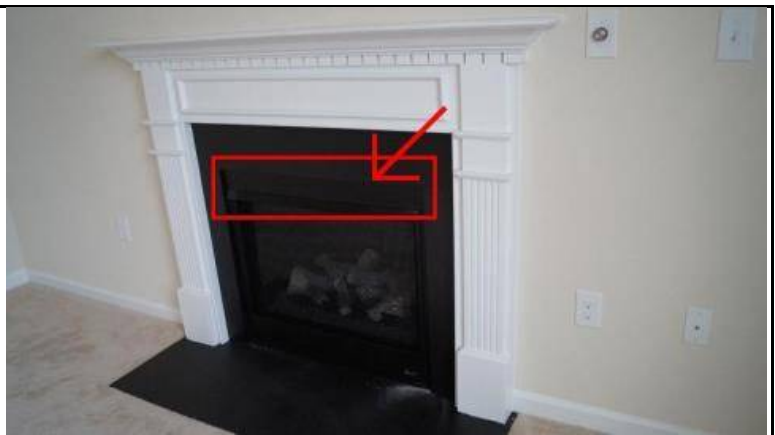
**Fossil Fuel Unit**

Left Side Fireplace was a Gas fueled unit with a blower.  
The unit was installed without a vent grille.  
The top section of the built in fireplace will need to be upgraded to a louvered grille to allow the air to flow into the Family Room.

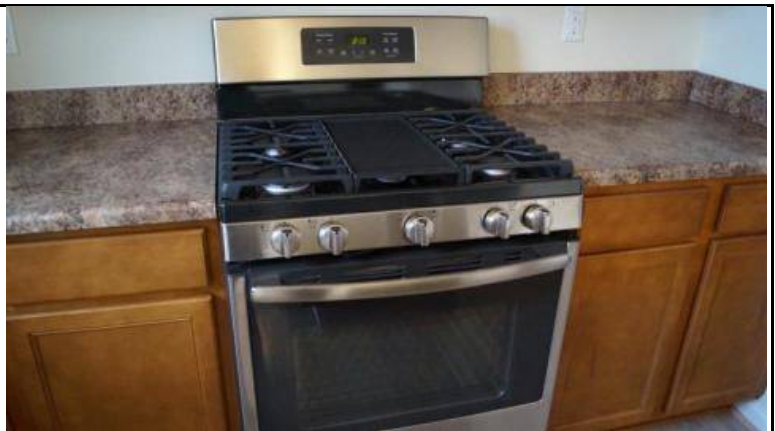
**Range/Oven:**

The range/oven appears to be functional.  
No food was heated up during this inspection.  
The inspector makes no attempt to determine if the unit has accurate temperature controls.  
Stove has not been secured as required by manufacturer's installation instructions.  
A tip-over hazard exists for small children.  
Stove should be properly secured right-away.

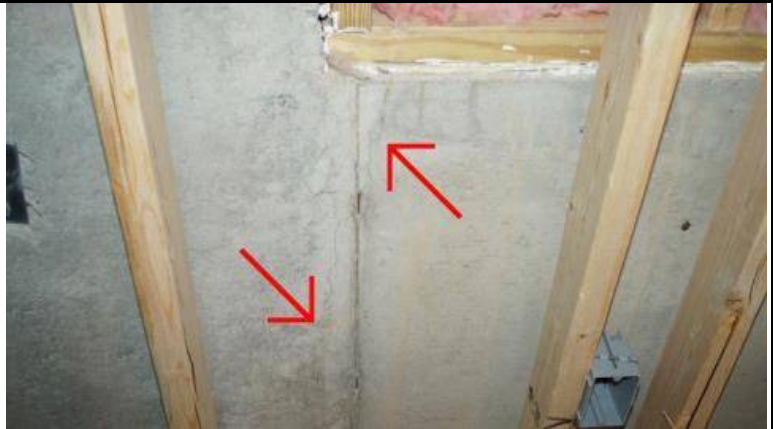
The exposed portions of the perimeter foundation wall at the left side near the AC unit has a vertical crack. This crack is minor in nature, however the crack extends through the poured concrete foundation wall. The poured concrete floor on the interior adjacent to the foundation wall has multiple cracks beginning at the Garage foundation wall. Though this could be considered typical settlement in the first 5 years. this house is less than 1 year since construction commenced.

There are no WV State Code Officials in this area, ask the builder for the 3rd party building inspections performed during construction. If there are no 3rd party inspection reports during construction, contact a WV Licensed PE that is licensed & insured as a Structural Engineer.  
(1). Provide a written analysis that the wall and foundation cracks are typical for a newly constructed house.

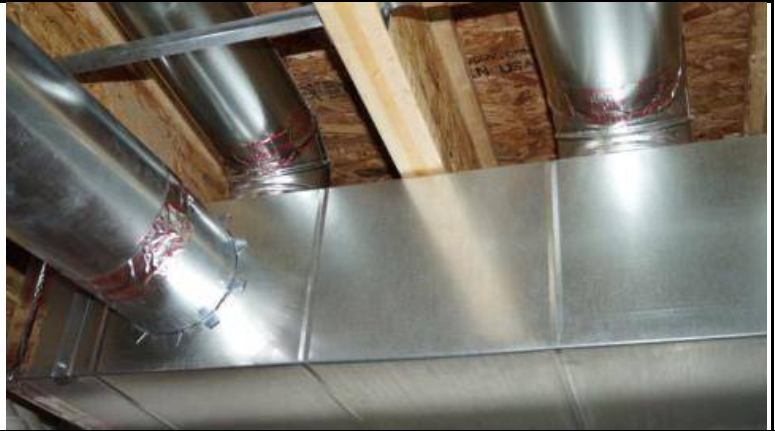
**Interior: Foundation Bolts**

The house was constructed with light frame construction. The State of West Virginia Fire Marshal requires that the underside of the floor area where the combustion appliances are located be covered or that the floor joist have been certified to comply with the standards regarding fire regulations.
