Housebusters Inc.
"Who You Gonna Trust...?"

This Inspection Report has been

Location of the Property
8888 Anywhere Street
World, US 00000

Summary Report

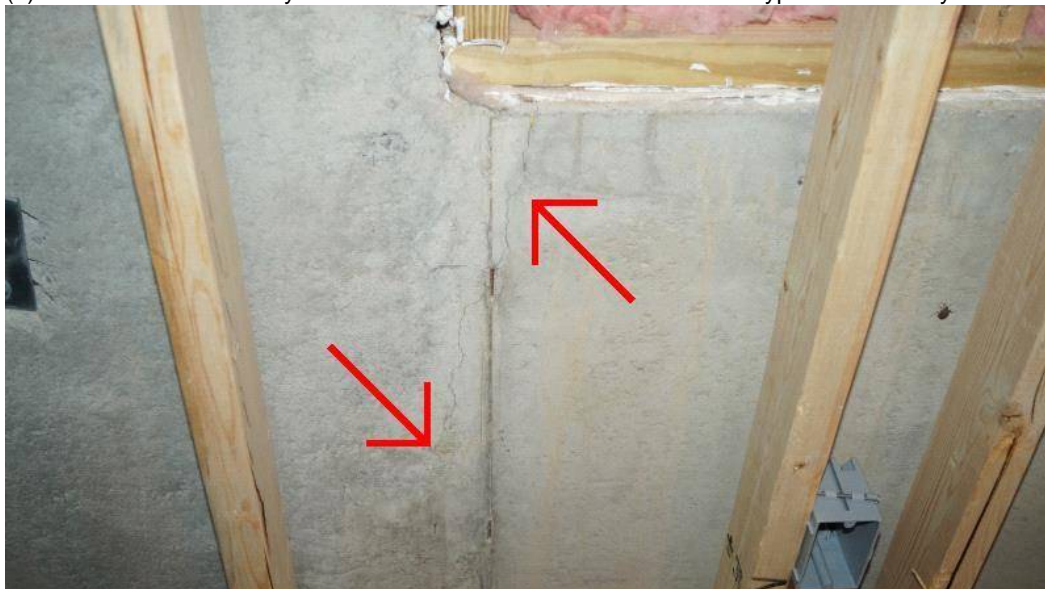
The exposed portions of the perimeter foundation wall at the left side near the AC unit has a vertical crack. This crack is minor in nature, however the crack extends through the poured concrete foundation wall. The poured concrete floor on the interior adjacent to the foundation wall has multiple cracks beginning at the Garage foundation wall. Though this could be considered typical settlement in the first 5 years. this house is less than 1 year since construction commenced.

There are no WV State Code Officials in this area, ask the builder for the 3rd party building inspections performed during construction. If there are no 3rd party inspection reports during construction, contact a WV Licensed PE that is licensed & insured as a Structural Engineer.

(1). Provide a written analysis that the wall and foundation cracks are typical for a newly constructed house.

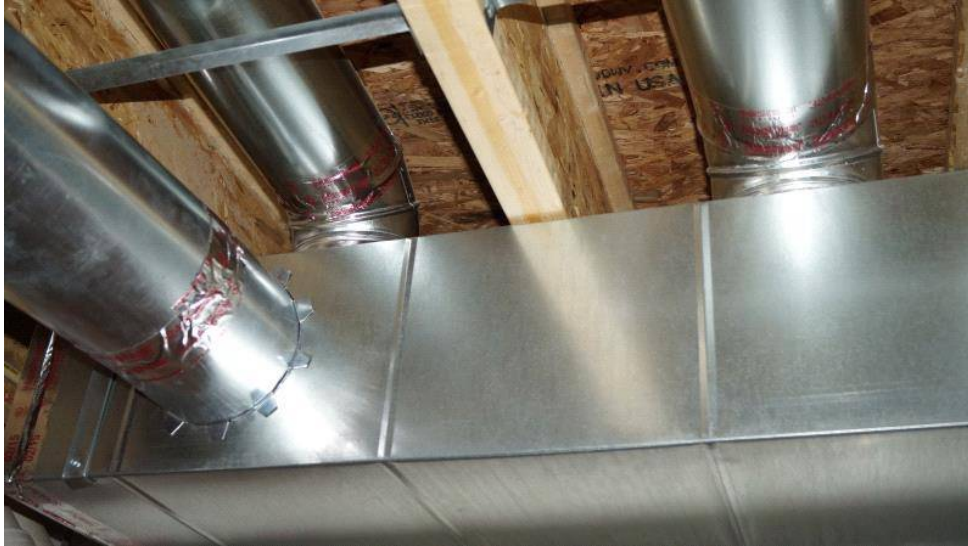
The house was constructed with light frame construction.

The State of West Virginia Fire Marshal requires that the underside of the floor area where the combustion appliances are located be covered or that the floor joist have been certified to comply with the standards regarding fire regulations.

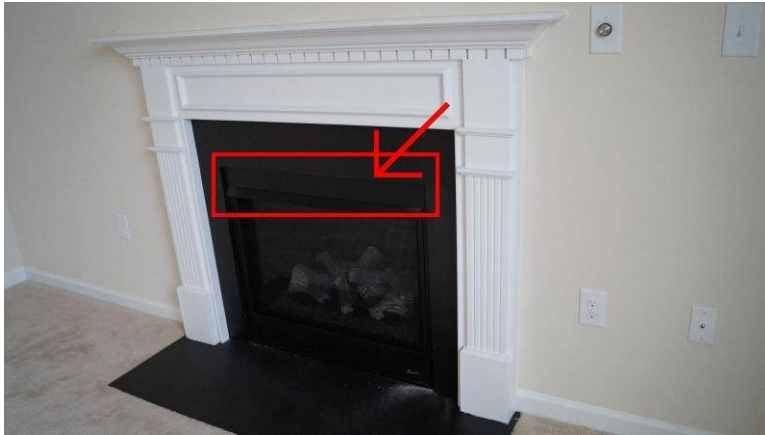
Left Side Fireplace was a Gas fueled unit with a blower.

The unit was installed without a vent grille.

The top section of the built in fireplace will need to be upgraded to a louvered grille to allow the air to flow into the Family Room.

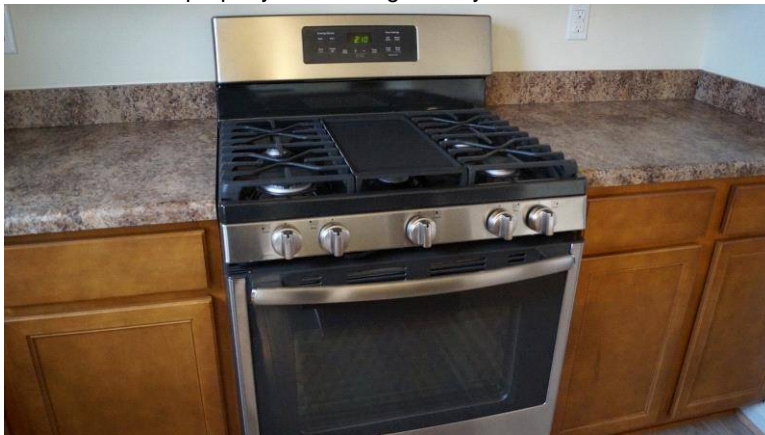
Stove has not been secured as required by manufacturer's installation instructions.

A tip-over hazard exists for small children.

Stove should be properly secured right-away.
