Foundation – Finished Basement

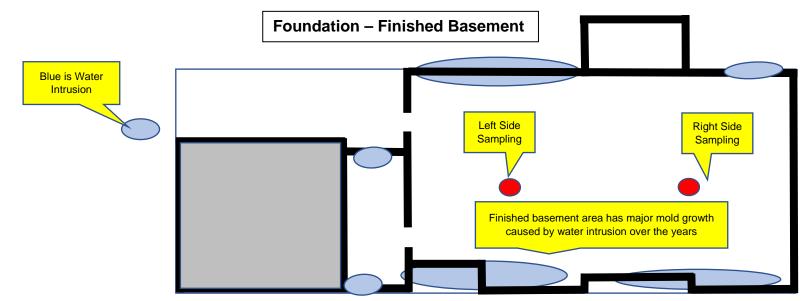
- Gutters overflowing
- Subsurface drainage system
- External foundation drainage system
- Elevated moisture at the bottom of the wall behind the drywall in the wood was greater than 25% in multiple locations.
- Moisture readings greater than 18% considered to be wet.

Remediation:

- Negative air device is suggested
- Drywall will need to be reviewed for the extent of the damage
- Ceiling tile are damp & require replacement
- Furnace duct system will need to cleaned and sanitized
